DELAWARE RIVER BASIN  
TRIBUTARY TO MAIDEN CREEK  
BERKS COUNTY  
PENNSYLVANIA  
NDS ID PA. 00721  
DER ID 6-460

# CHRISTMAN DAM

## PHASE I INSPECTION REPORT NATIONAL DAM INSPECTION PROGRAM

MARCH 1980

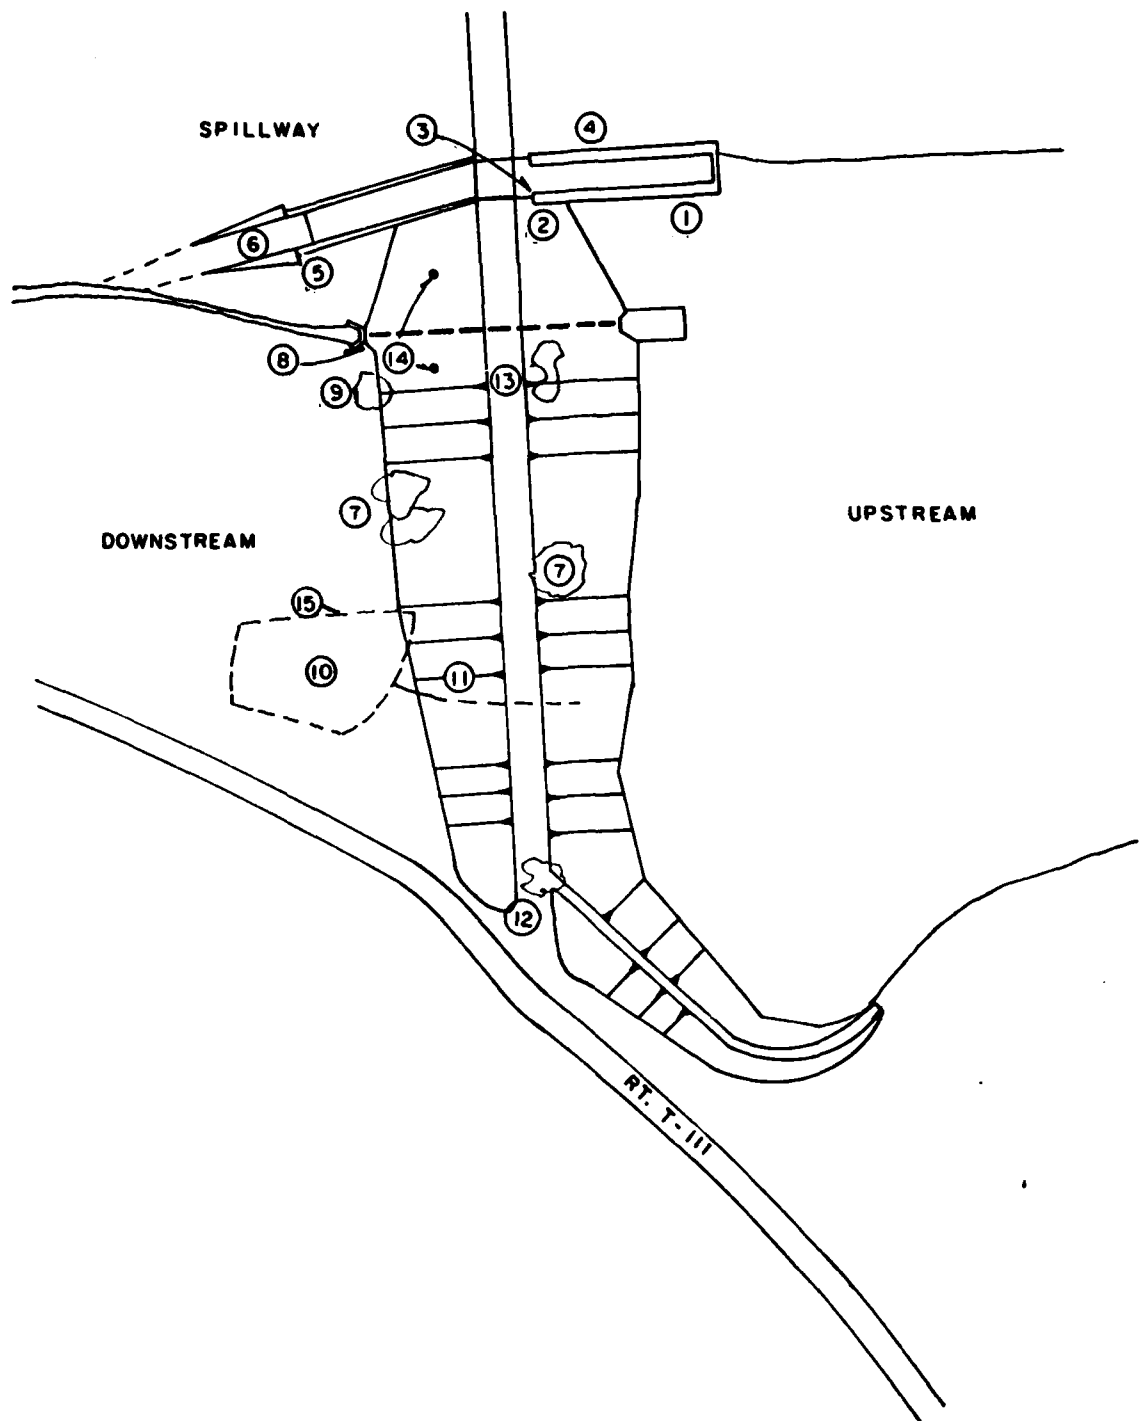
SHEET 5A OF 11

Between the spillway chute and the discharge conduit outlet, slightly downstream of the toe, a marshy area was noted, as shown on sheet 5a, Appendix A. Seepage was also noted exiting the embankment from the left side of the outlet conduit, as shown in Photograph 13. This seepage could either be embankment seepage intercepted by the rock toe or seepage along the conduit.

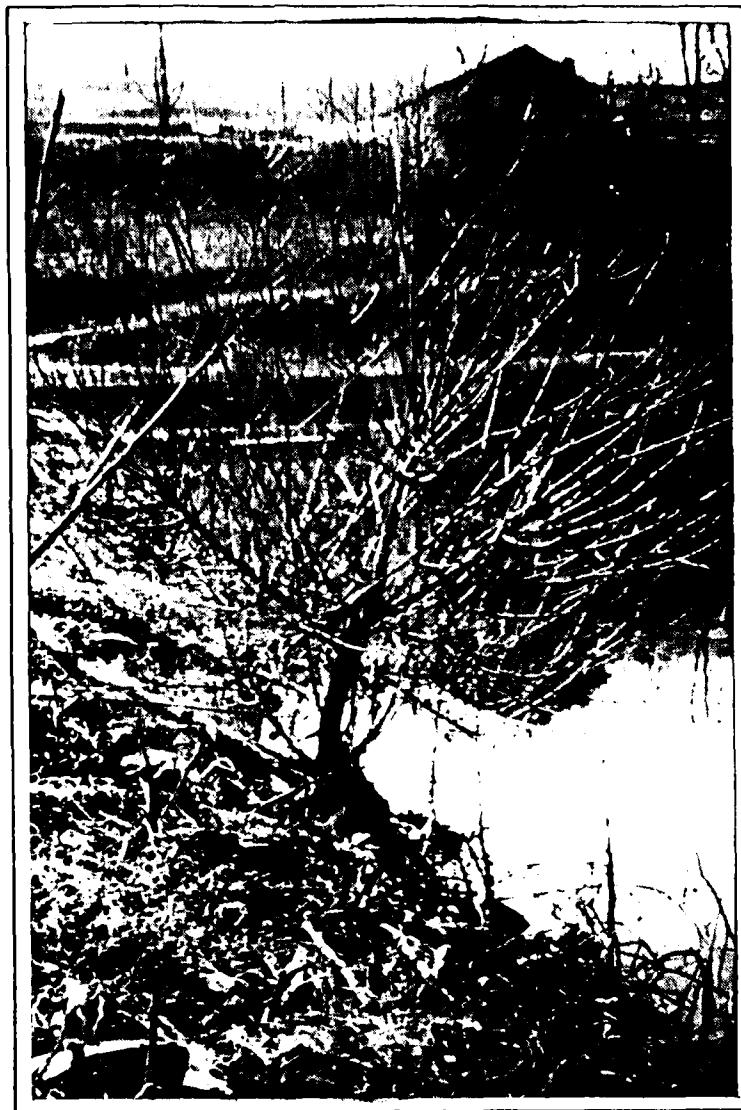
PHOTOGRAPH NO. 5

Although the upstream slope at the waterline is at least partially protected by riprap, a bench was noted just below the water surface. Additional stone has been placed on the upstream slope adjacent to the spillway, as shown in Photograph 15, Appendix C, which reduces the spillway capacity. Fairly large trees are currently rooted in the riprap zone; see Photograph 5. Other large trees grow on the downstream slope; see Photographs 7 and 8. It is noted that some trees have been removed, except that the root mass has been left in the embankment. The downstream slope is protected with Crownvetch, but also supports several large trees and other woody vegetation. The downstream slope near the maximum section was damaged, possibly by a truck or track mounted vehicle, when piezometers were installed; see Photograph 9. This damage should be repaired.

UPSTREAM SLOPE.

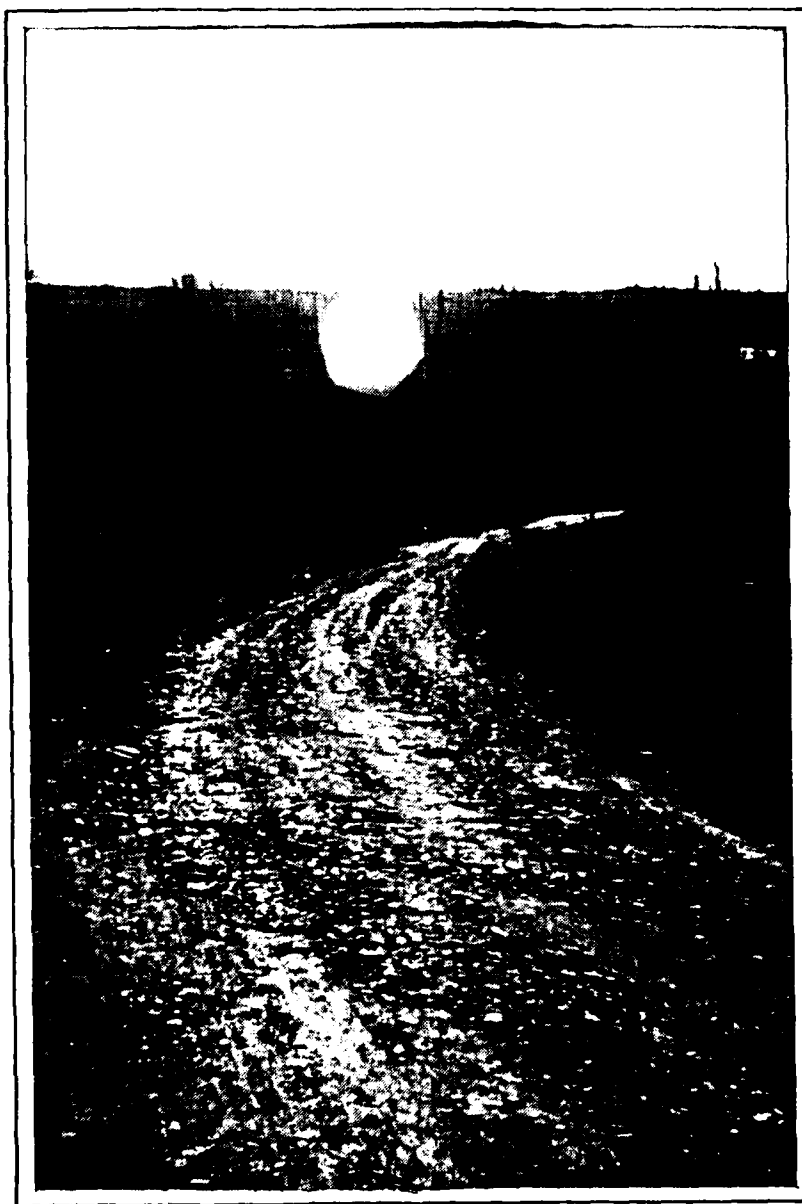
PHOTOGRAPH NO. 6

ROADWAY OVER DAM. GRAVEL  
WAS RECENTLY ADDED TO A LOW  
SPOT.

- (1) The embankment stability analysis requested by the state should be performed, using constructed slope angles and as-built soil parameters obtained from undisturbed samples.
- (2) The crest elevation should be increased to meet the design elevation.
- (3) The trees and root masses should be completely removed and the slope restored to its original condition. All woody vegetation should be cut on an annual basis.

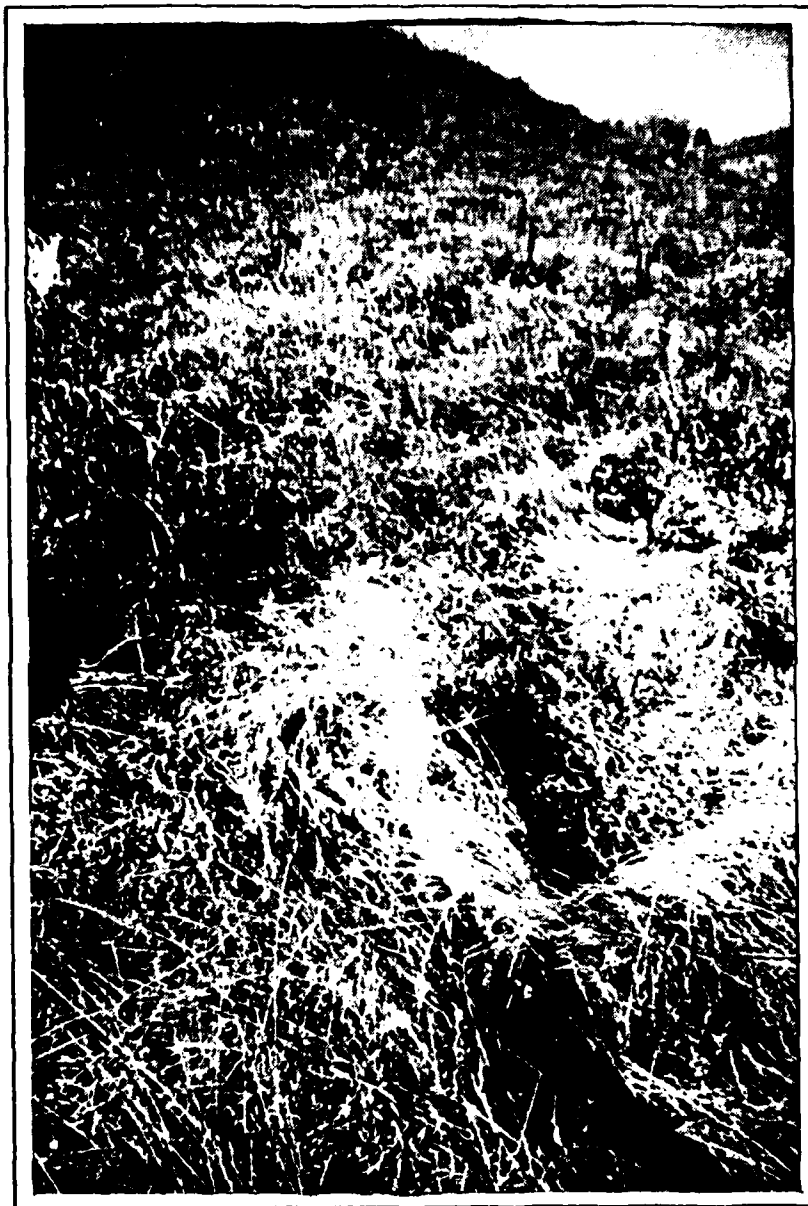
PHOTOGRAPH NO. 12

To the left of the outlet conduit is a 1.5 inch I.D. hose. Photograph 11 shows the intake on the upstream side; Photograph 12 shows the exiting end of the hose. The hose passes through the embankment at an undetermined depth below the crest. The original purpose of the hose was to supply water to the fish ponds at the downstream toe. Reportedly, the intake to the hose is blocked with a piece of wood. There are three fish ponds on the downstream edge of the embankment. The one at the lowest elevation can be seen in the overview photograph and Photograph 7. Seepage was noted to be flowing from the base of the fish pond embankment, and the pond could be masking seepage through the embankment.

HOSE FORMERLY USED TO SPRAY  
WATER ON FISH POND.

- (4) Additional backfill should be placed behind the spillway chute walls.
- (5) The riprap partially blocking the weir should be removed.
- (6) The hose through the embankment should be removed and the embankment returned to its original condition.
- (7) Provide a method of upstream closure of the pond drain conduit.
